SERVICE BULLETIN SB0012

SUBJECT: Aileron Cable Pulley Diameter Inspection

MODELS AFFECTED: CC18-180A SERIAL NUMBER 0001

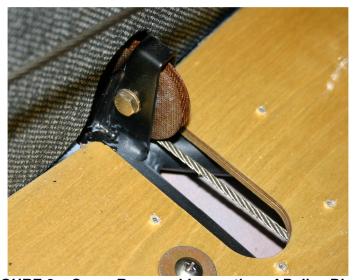
FIGURE 2 – Cover Removed-Inspection of Pulley Diameter

diameter on the lower aileron cable pulley, located in the cabin. This caused the cable to ride on top of the pulley causing

2. The correct pulley diameter is 1.75". The cable guard should be close enough to the cable that it would be impossible for the cable to come out of the "V" groove in the pulley. If an incorrect 1.5" pulley is installed on either or both sides, please contact Cub Crafters with a request for the correct diameter pulley or pulleys.

3. If the correct pulley (1.75" diameter) is installed, no further action is required. Make appropriate logbook entries stating SB0012 has been complied with.
